Manhole Inspection Summary

Manhole # S37II1007MH

Insp Date: 1/11/07 5:24 PM

Location Address: **4025 OLD YORK RD**

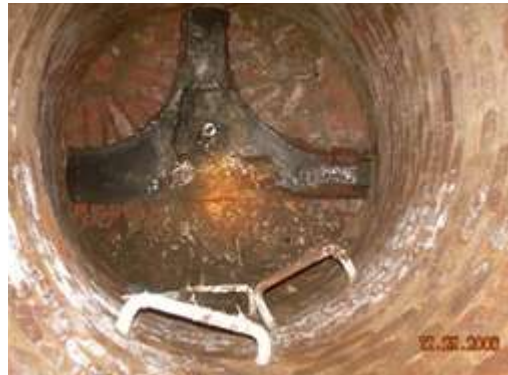
Top View

Corrod steps. Evidence of surcharge -
Bench debris. Channel debris.

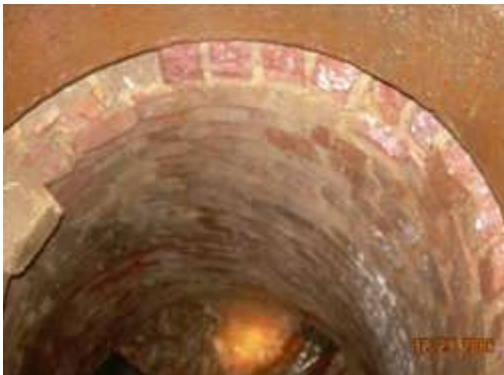
Defect

Frame leaks. Frame offset. Adjustment
deterioration, loose brick and infiltration.
Corbel and Barrel infiltration.

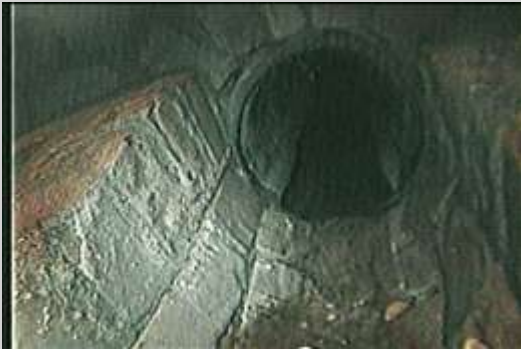
8 in. Circular Gravity Sewer Pipe Out @ 12 O'Clock

Deposits: ☐ None ☒ **Mud** ☐ Sludge ☒ **Debris** ☐ Grease

Silt Depth: **0** (in.) Deposits Extent: **Light**

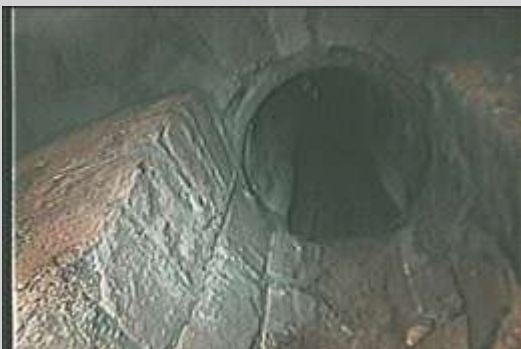
8 in. Circular Gravity Sewer Pipe In @ 3 O'Clock

Channel deterioration.

Infiltration: **Evidence** Pipe Seal Cond: **Cracked**

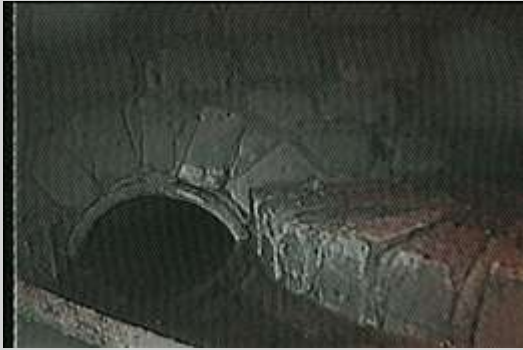
8 in. Circular Gravity Sewer

Deposits: ☐ None ☒ **Mud** ☐ Sludge ☒ **Debris** ☐ Grease

Infiltration: **Evidence**

Pipe Seal Cond: **Cracked**
